**ANALYTICAL RESULTS REPORT
SITE INSPECTION**

**GOLD HILL TAILINGS SITE
EPA ID# COD983801275**

**U.S. ENVIRONMENTAL PROTECTION AGENCY
REGION VIII**

October 14, 1994

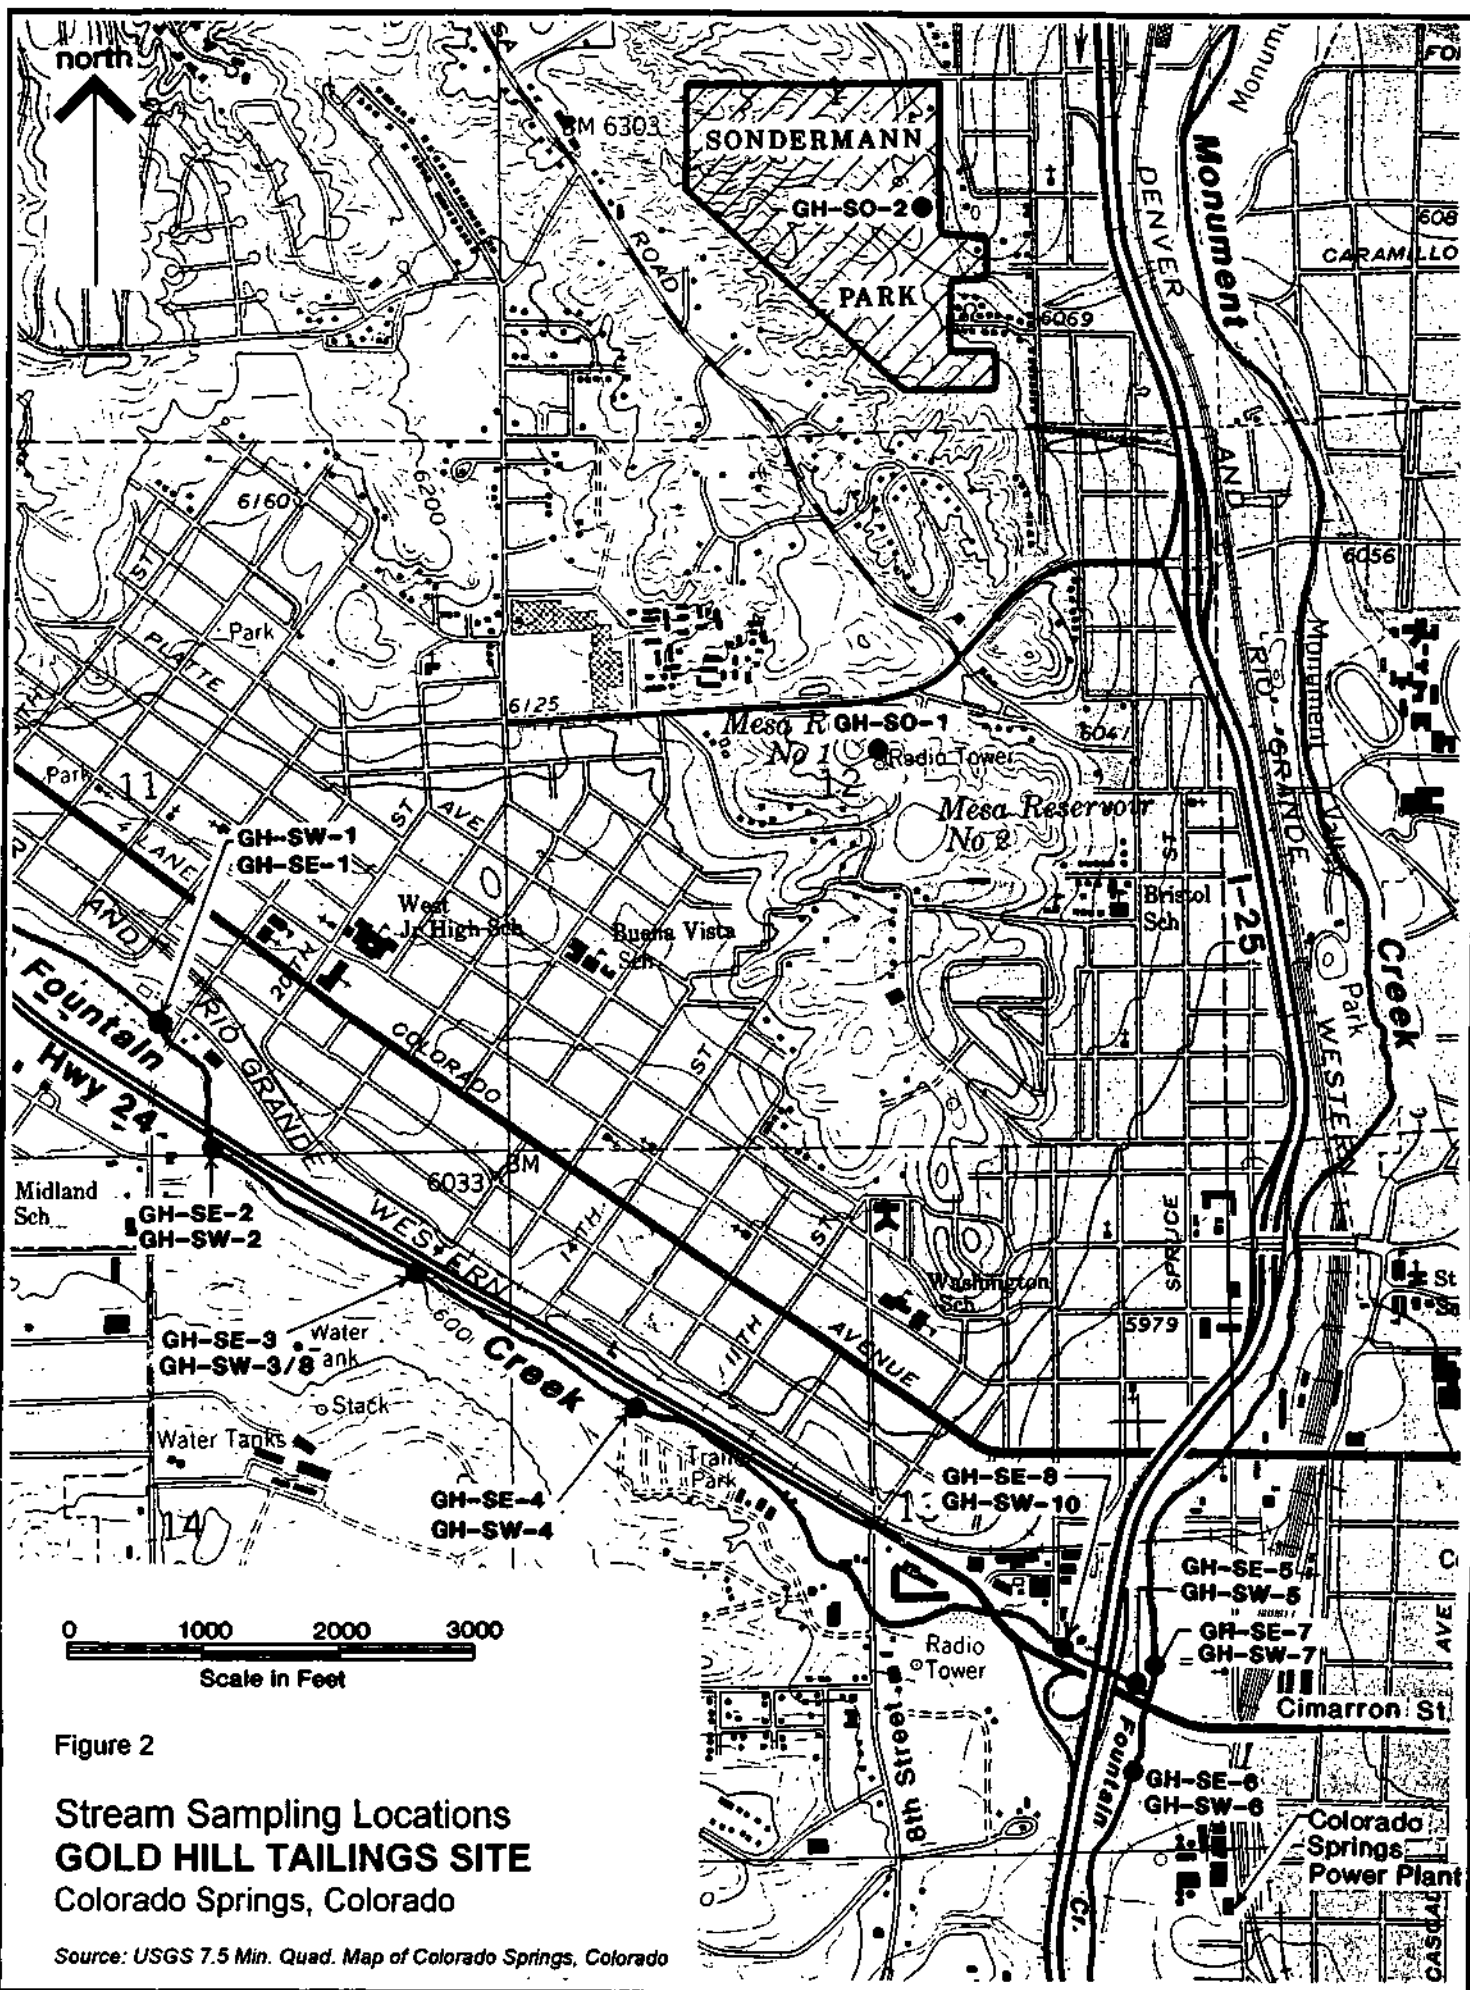
Figure 2

Stream Sampling Locations GOLD HILL TAILINGS SITE Colorado Springs, Colorado

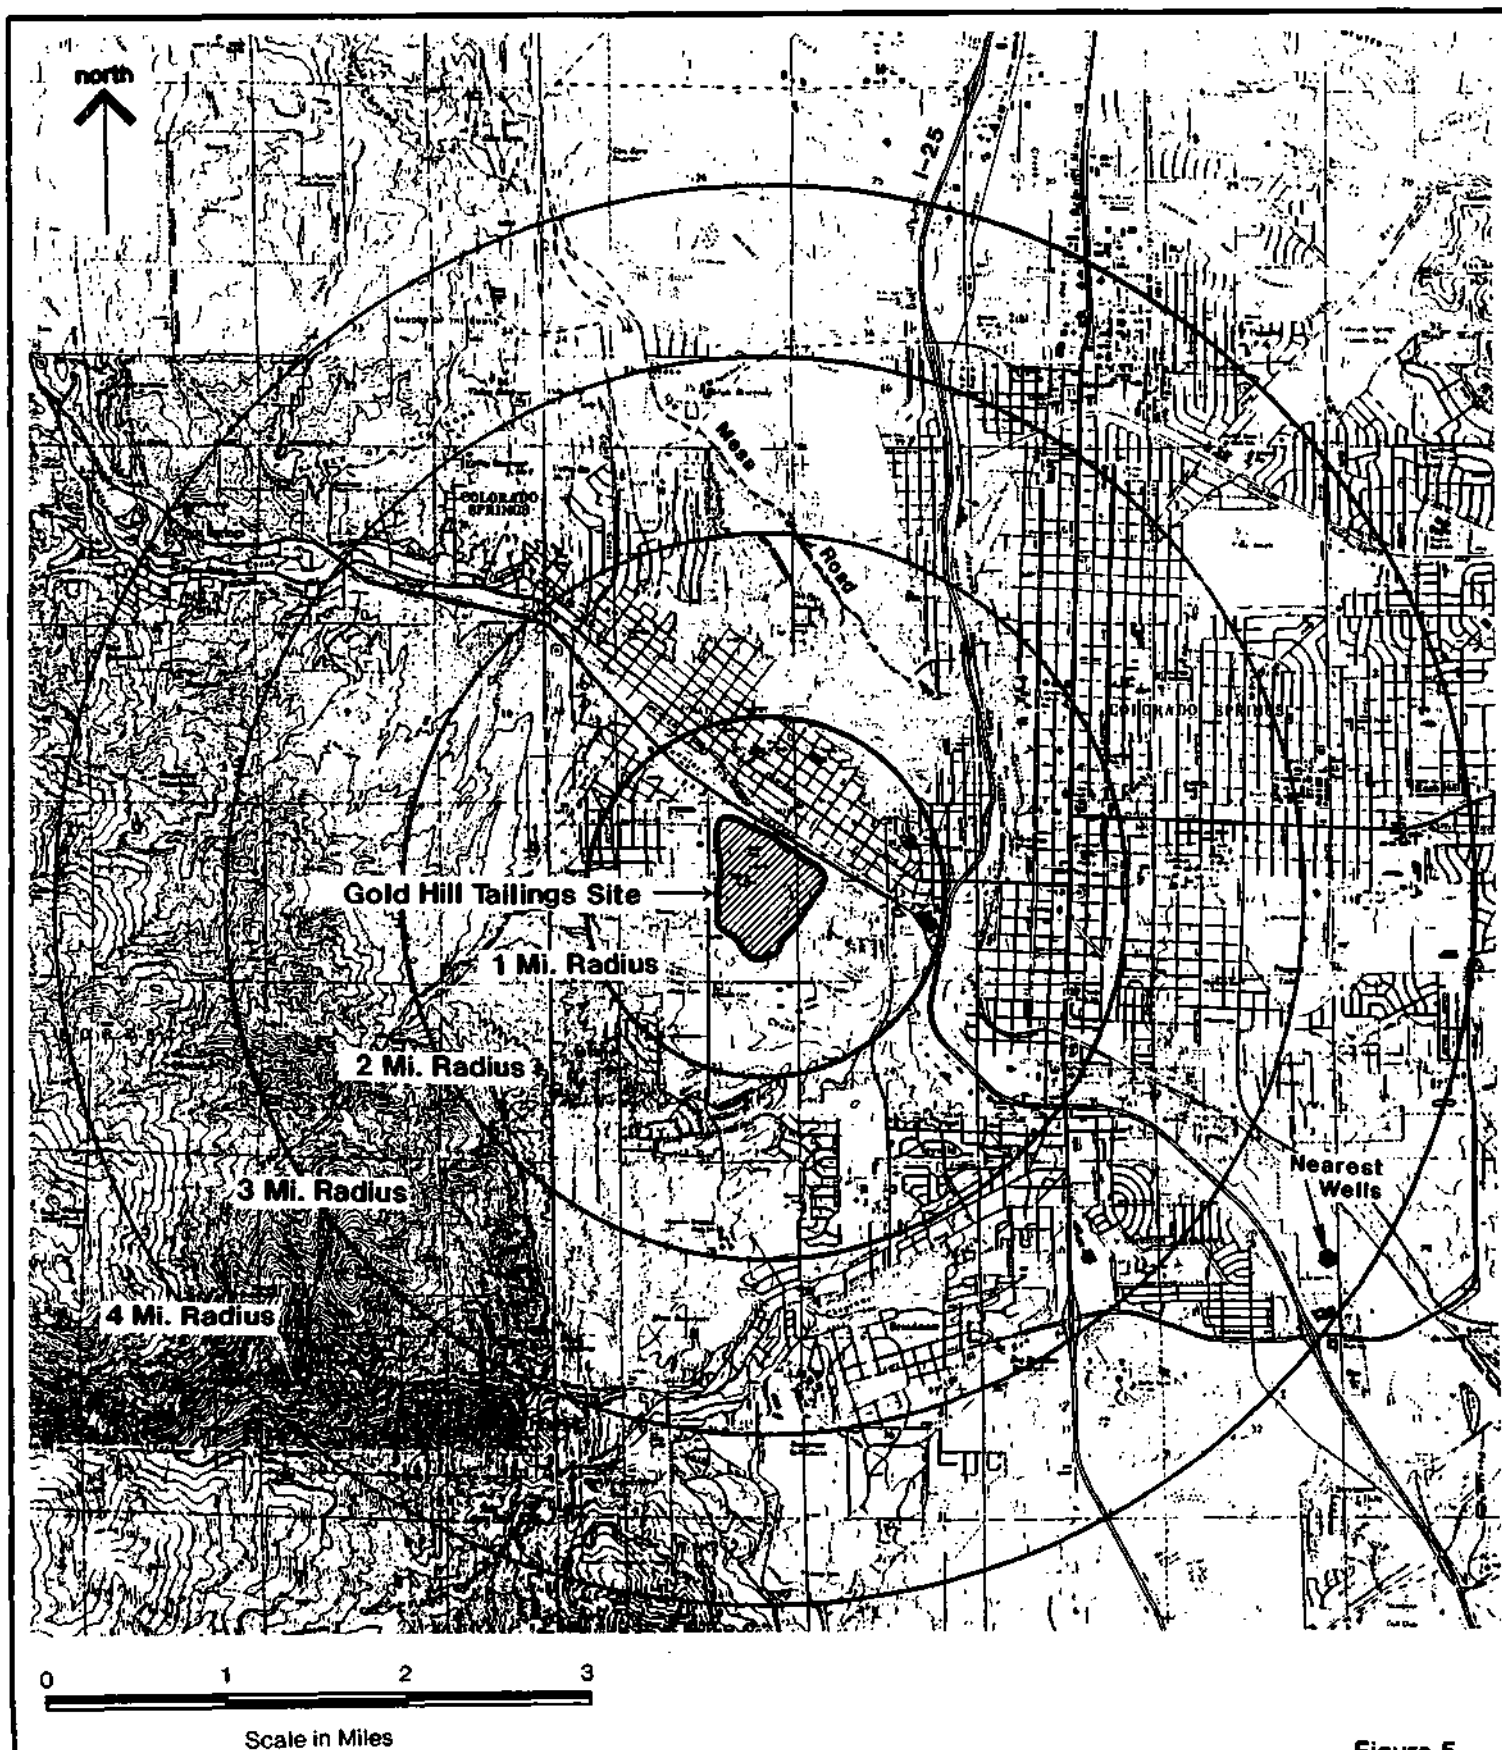
Figure 5

4-Mile Radius Map
Gold Hill Tailings
Colorado Springs, Colorado

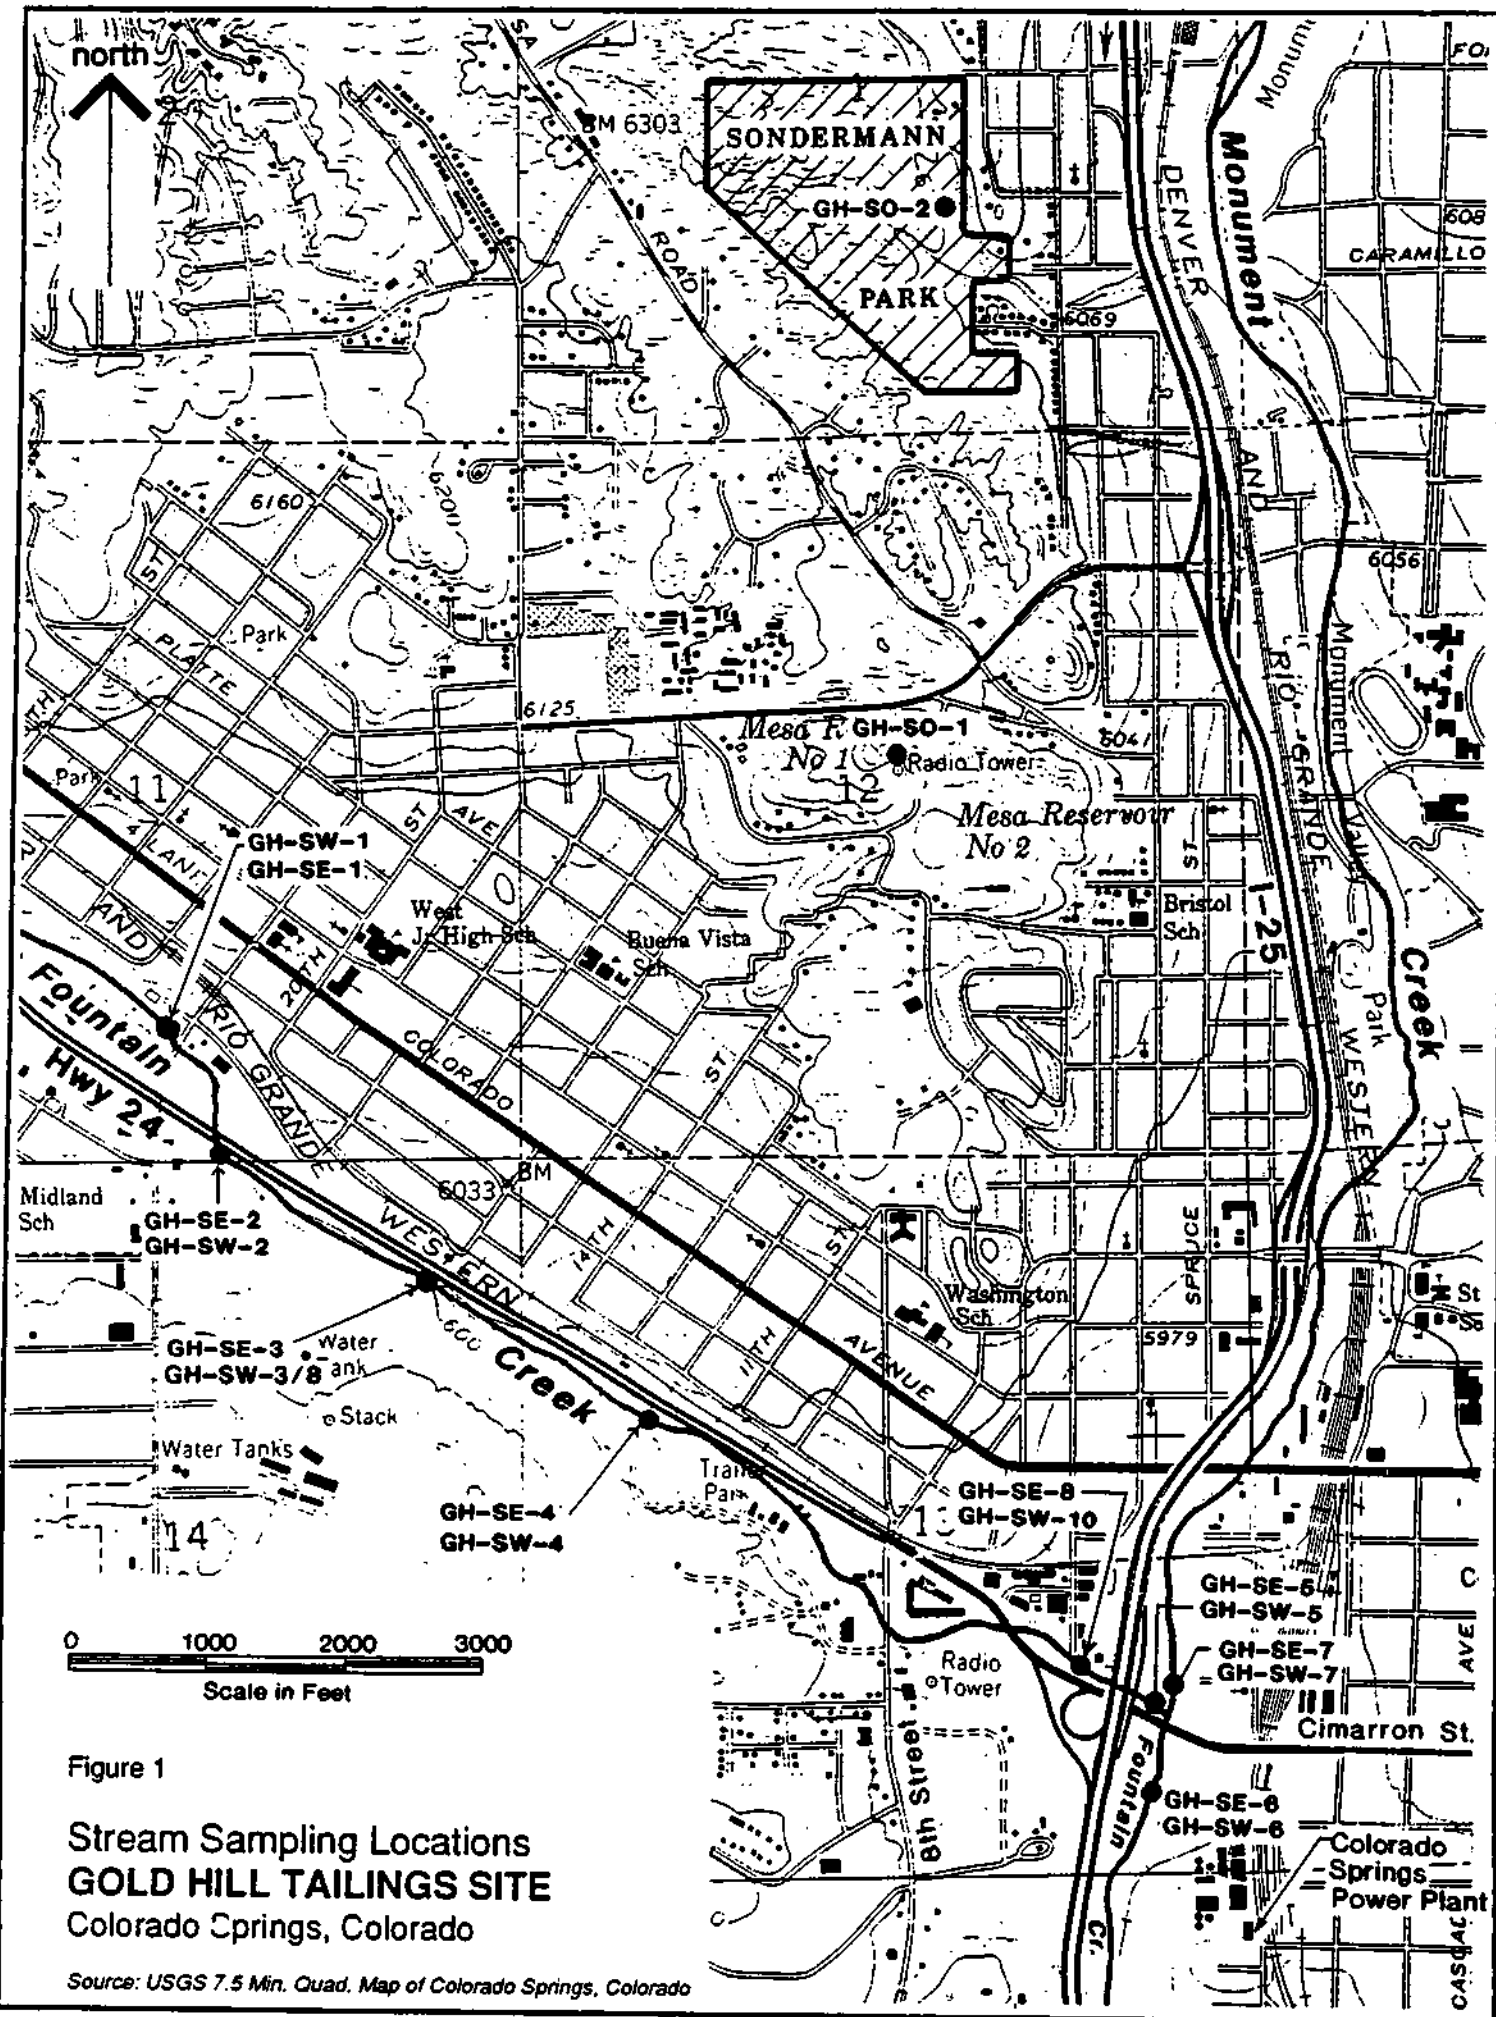
Figure 1

Stream Sampling Locations **GOLD HILL TAILINGS SITE** Colorado Springs, Colorado

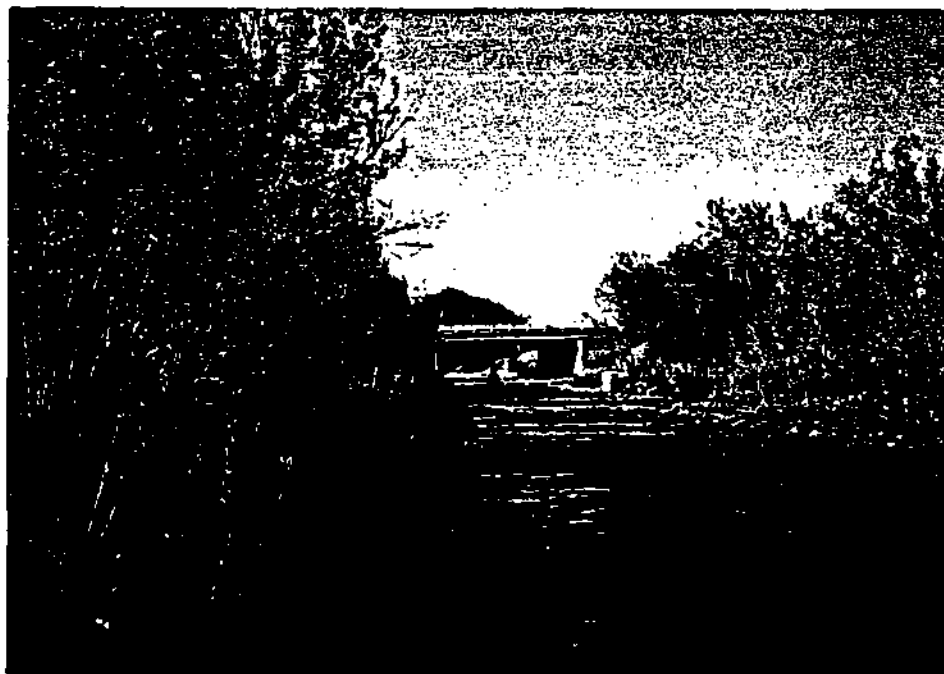
12

0.1 mile of wetland frontage (see photo #12). This sample point is located downstream of the mixing zone below the confluence. This mixing zone was obvious because of color differences in the creeks. Above the confluence Fountain Creek was a turbid, rust-brown color. Monument Creek was a turbid greenish-gray color (see photo #11). The mixing zone extended downstream from the Cimarron Street bridge.

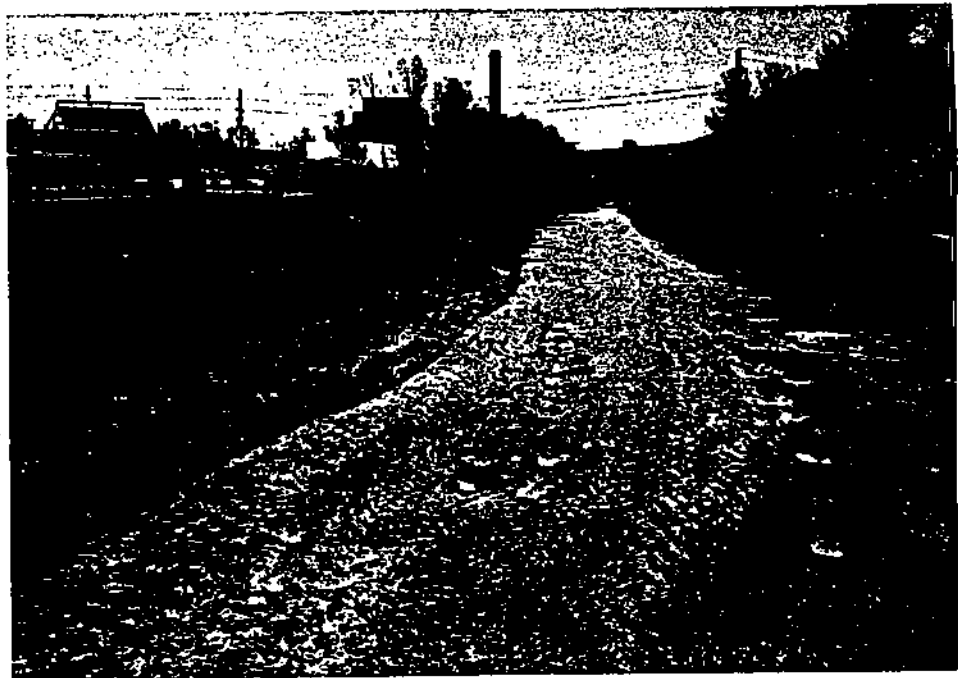
28

Photographer/Witness Mark Lunsford
Date 5/11/94 Time _____ Direction South
Description View of Monument Creek downstream (south) from RR bridge north of
confluence with Fountain Creek. Line of young willow trees on east bank (at left) demarcates
edge of wetland fringe.

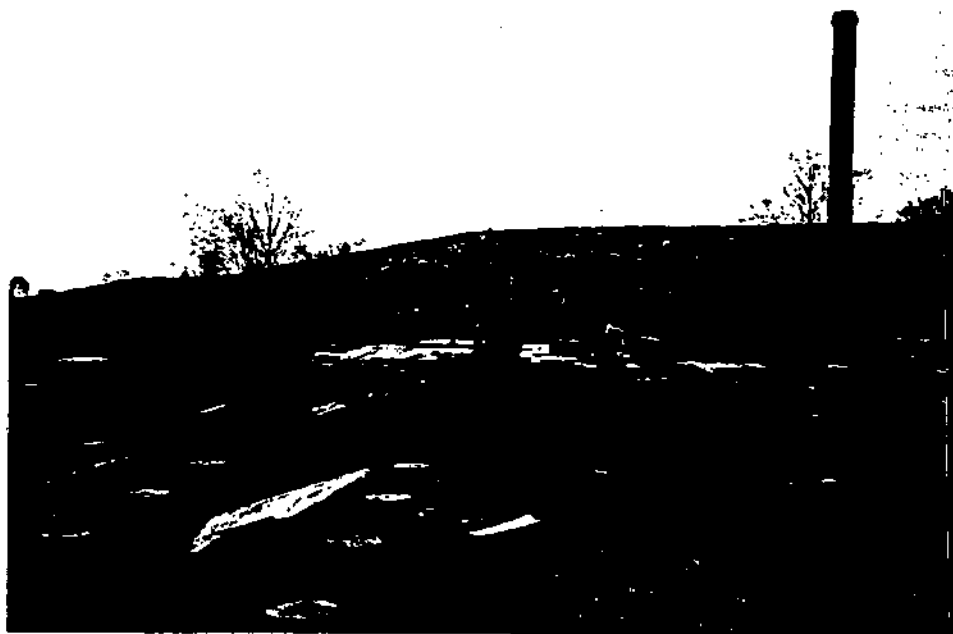
32

Children were observed playing on suspected tailings material near the A-1 Mobile Village/site boundary (see photo #31). Youths were also observed in the mill site area (see photo #32) in the vicinity of the former Tin Box and Precipitating Rooms and jumping across on elevated platforms at the roasting furnace (see photos #22 and 23 and Figure 2). A long trench and manholes in the Tin Box and Precipitating room floors were open to basement areas where water has accumulated. Leakage from the basements may have caused the saturated soil conditions that were noted in the mill site area. A motorcyclist and bicyclists also were observed onsite on May 11 (see photo #33).
